Manhole Inspection Summary

Manhole # S09GG2023MH

Insp Date: **7/10/06 1:45 PM**

Location Address: **6200 GREEN MEADOW PKWY** Cross Street: **EDENVALE RD**

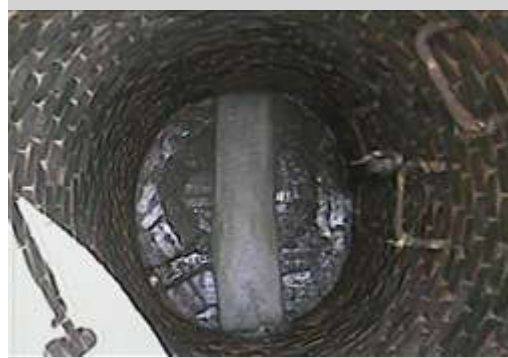
Top View

Corroded steps. Evidence of surcharge

Evidence of surcharge

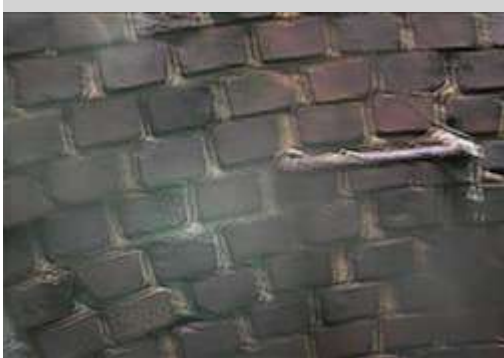
Evidence of surcharge.

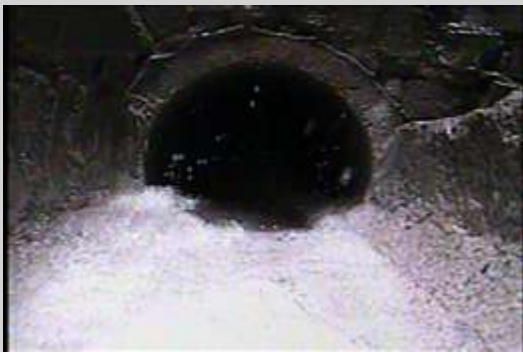
12 in. Circular Gravity Sewer Pipe Out @ 12 O'Clock

Pipe Material: **Clay** ☐ Pipe Lined

Invert Depth: **12.84** (ft.) Flow Characteristics: **Turbulent**

Infiltration: **None** Pipe Seal Cond: **Unknown**

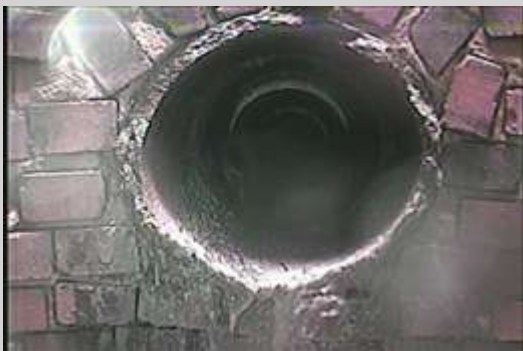
12 in. Circular Gravity Sewer Pipe In @ 6 O'Clock

Pipe Material: **Unknown** ☐ Pipe Lined

Invert Depth: **10.03** (ft.) Flow Characteristics: **Turbulent**

Infiltration: **Evidence** Pipe Seal Cond: **Roots**

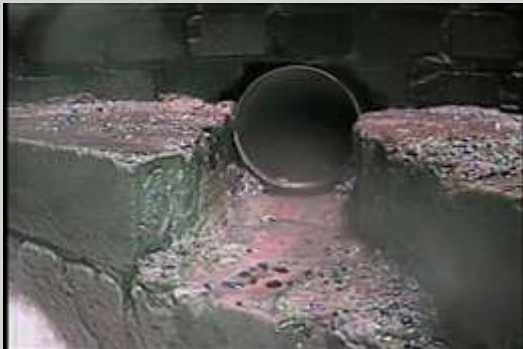
6 in. Circular Gravity Sewer
Pipe In @ 8 O'Clock

Pipe Material: **PVC** ☐ Pipe Lined

Invert Depth: **11.60** (ft.) Flow Characteristics: **None**

Connects To: **House connection / Service line**
